In-service Corrosion Issues in Sustainment of Naval Aircraft

By: Rick Mendoza NAVAIR North Island Advanced Structures Design Group 28 August 2012

Corrosion Issues

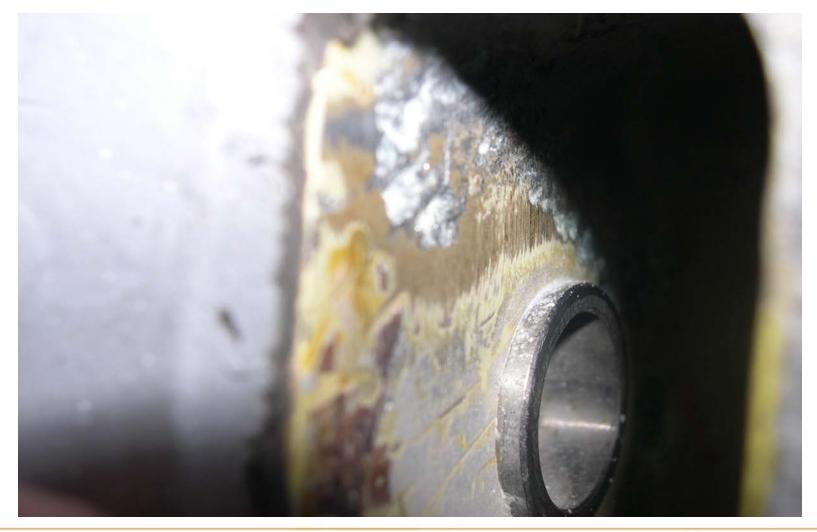
CORROSION ON Y395
